# **BurruP Common User Transmission Infrastructure – Preliminary Documentation**

**EPBC Number: 2022/09407**

05 February 2024

**HORIZON**  
POWER

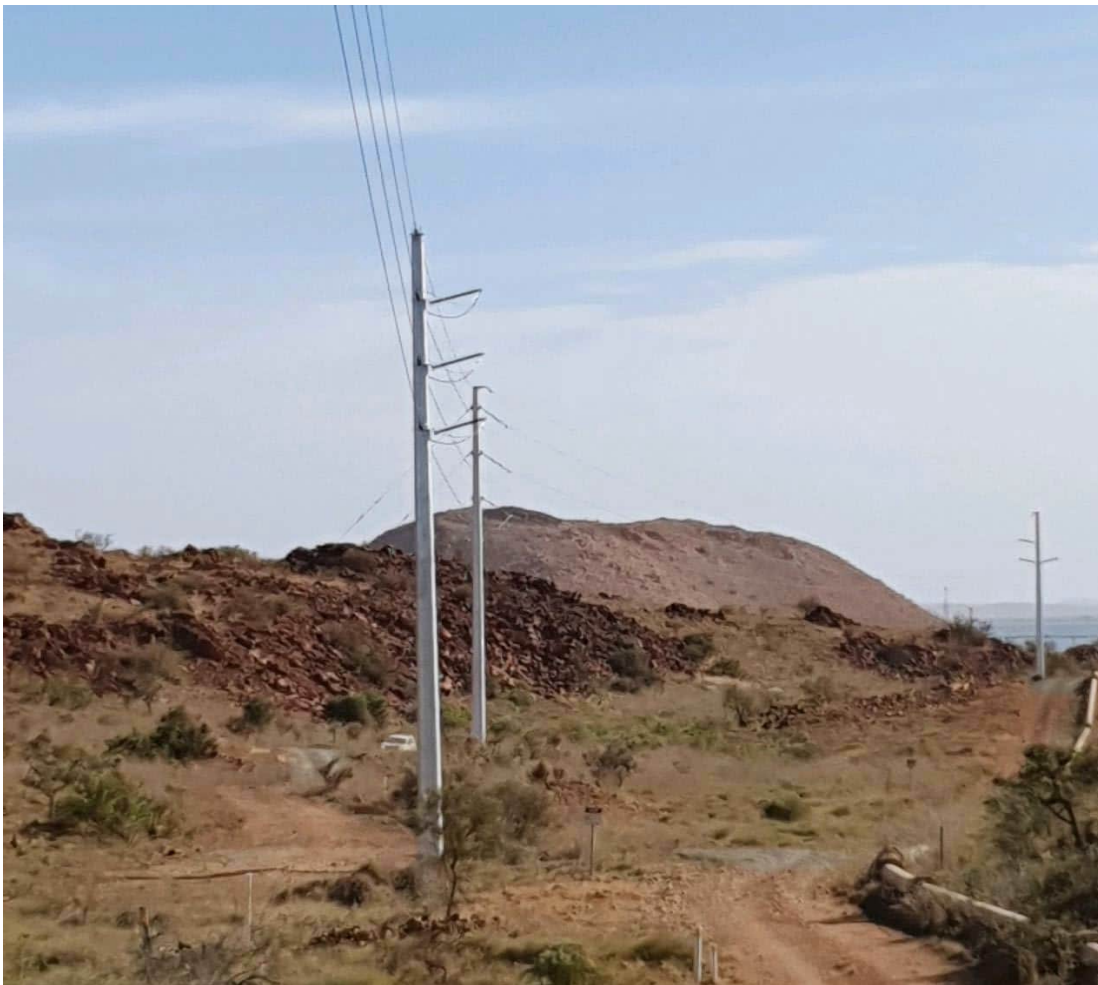
Photo 1 – Example Transmission Poles

The poles will be constructed with suspended insulators and the conductors will be spaced approximately 230 cm apart, with an approximately 100 cm distance from crossarm to energised parts (as shown in Photos 1 and 2) which complies with the low risk category in the recommendations developed by BirdLife International to inform the drafting of *International conventions on the protection of birds from collision with power lines* (BirdLife International, 2007).

- Permanent elements
  - approximately 7 km long 132 kV overhead transmission line;
  - approximately 40 poles and cleared pole access pads (40 m x 20 m), and associated pole stays along the transmission line route. The poles will be constructed on top of concrete pile foundations and secured down by ragbolts;
  - cleared, unsealed access track along the transmission line route required for maintenance during operations;
  - Burrup substation (inclusive of 33 kV and 132 kV switchgear, large scale battery, transformers, fencing, lighting and ancillary equipment);

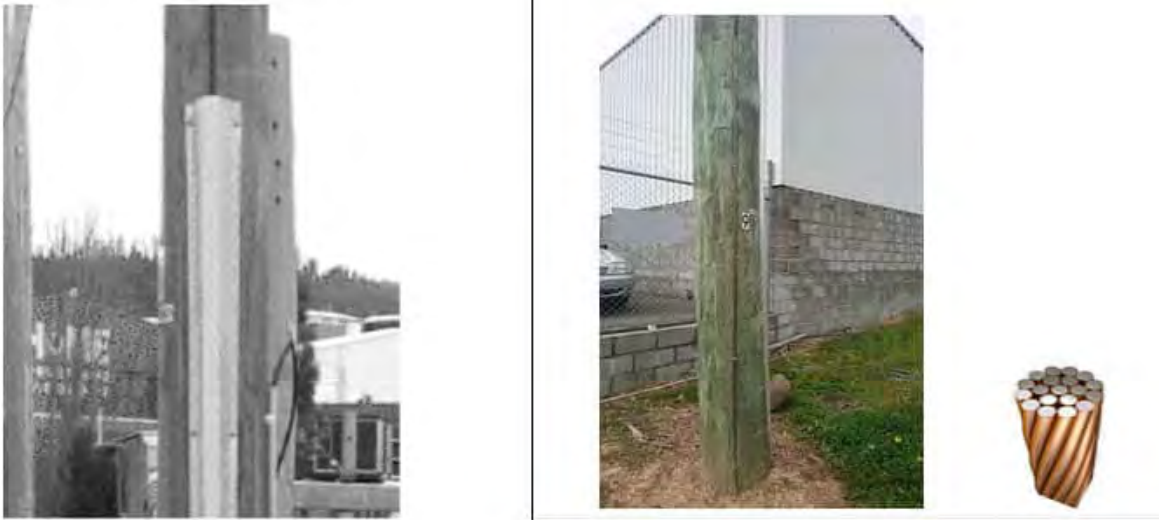
**Figure 3: Pole earth copper theft is resisted by steel covers or using copper clad steel**

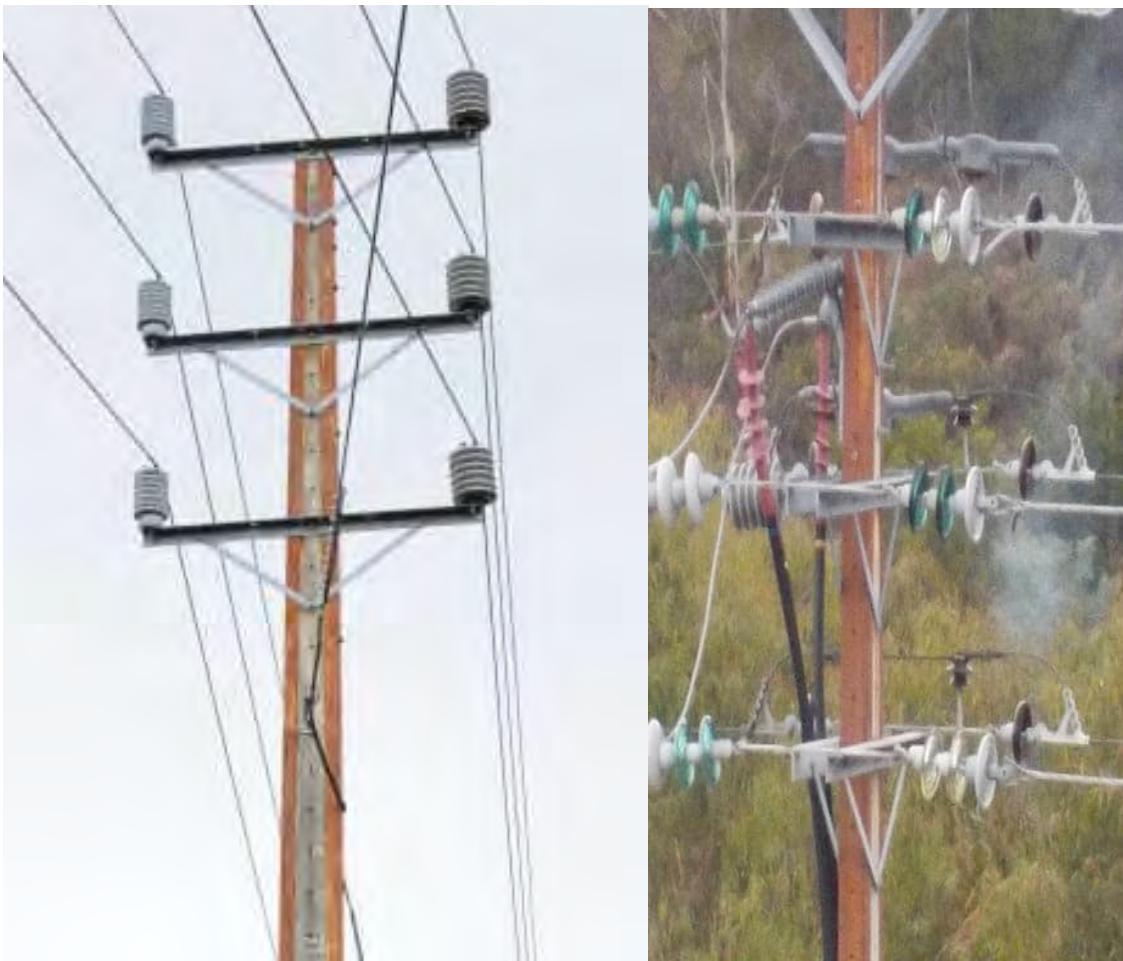
**Figure 4: Steel HV cross arms and insulators on dual circuit 33kV and 33 kV and 11kV circuits on a stobie pole**

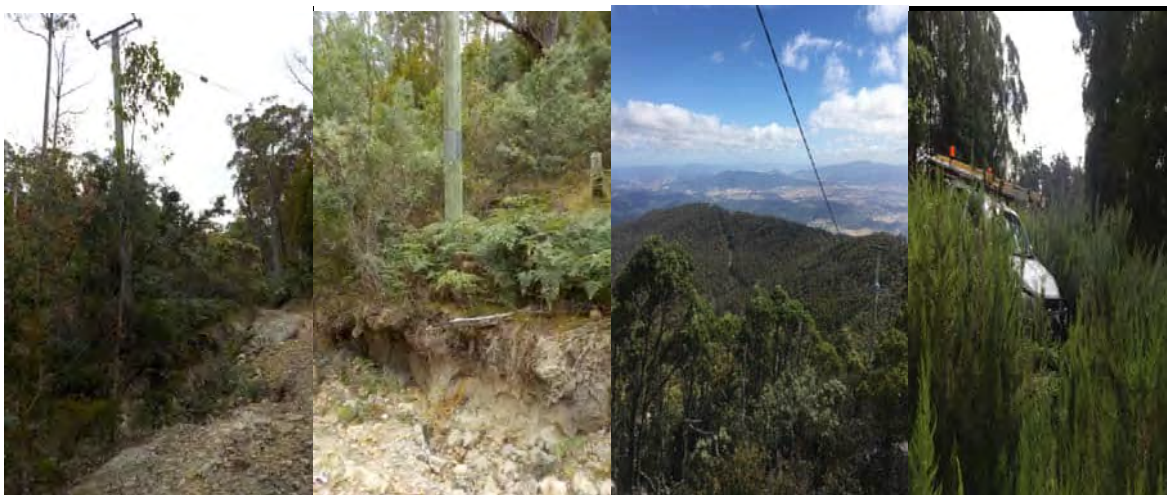
**Figure 28 Examples of high slope access tracks & track washout near pole footing**

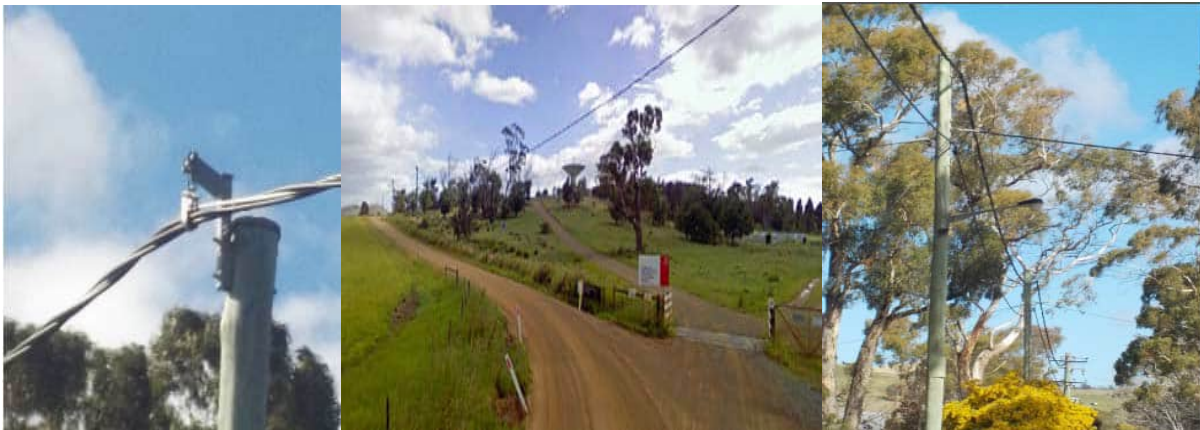
**Figure 32 existing non-metallic screened (NMS) HV ABC conductor**

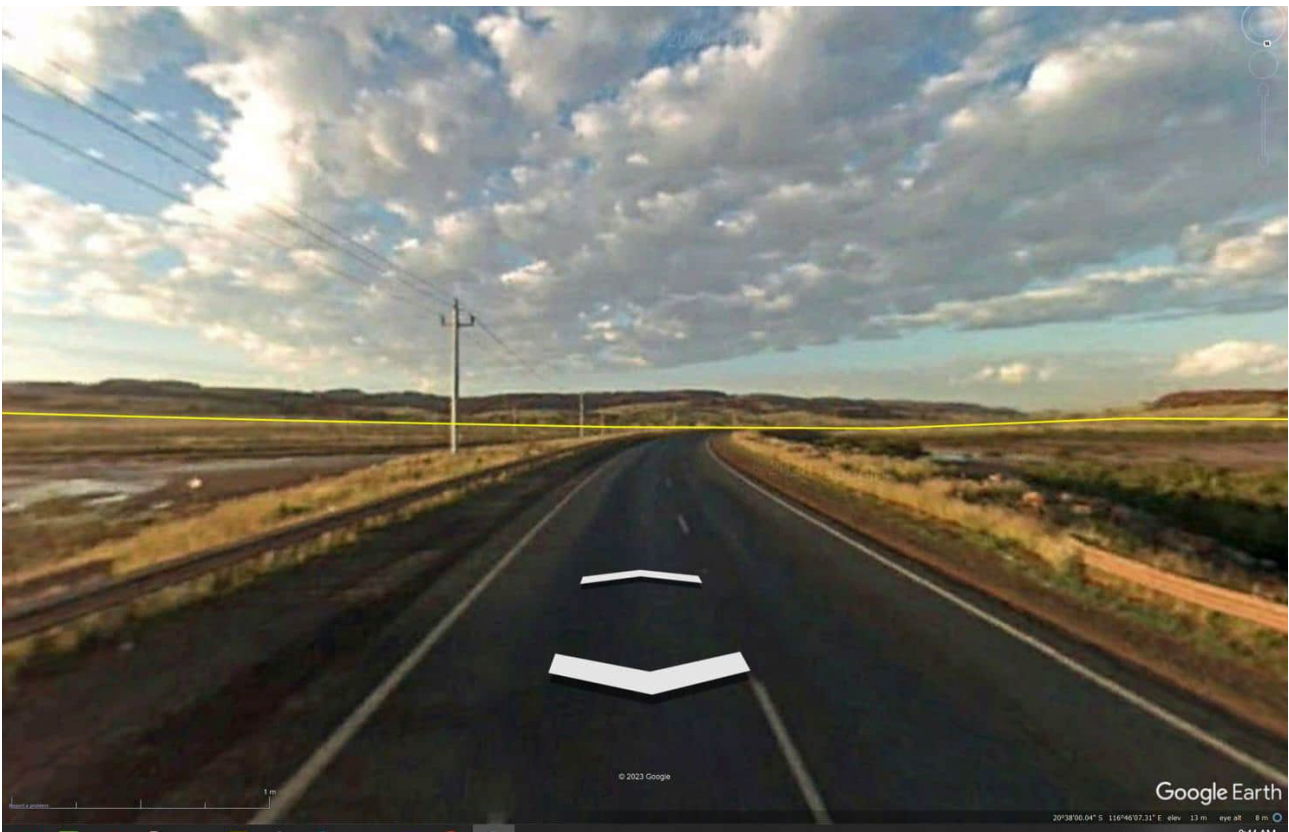
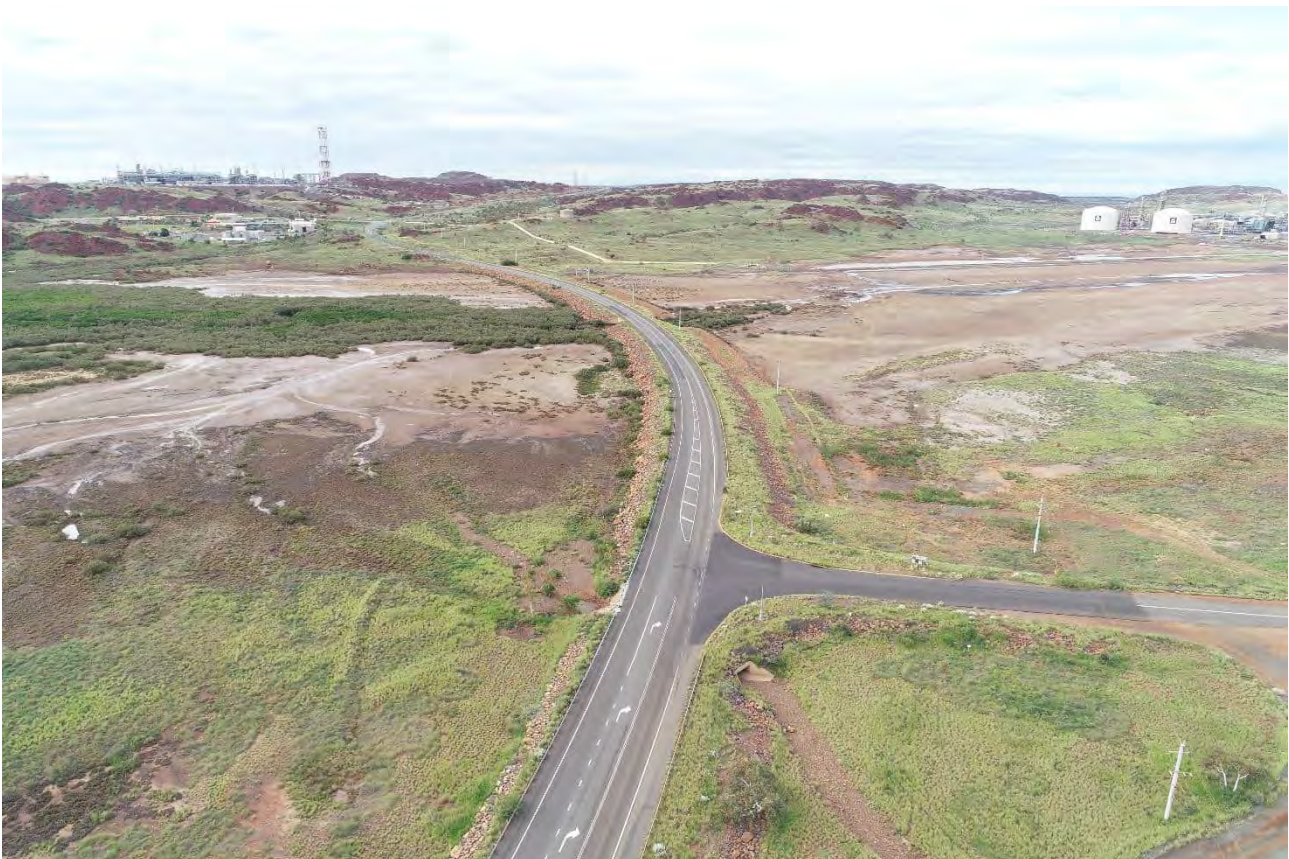
**Photos 3 and 4 - Burrup Road causeway and existing distribution power lines looking north across intertidal area (this is an older photo and further clearing has been undertaken in the vicinity by third parties since this was taken)**

The section of the intertidal area which lies within the proposed DE is traversed by an existing distribution power line and Burrup Road, which is a two-lane sealed road atop a crushed rock causeway with a large central culvert to permit tidal movements of water underneath the road infrastructure. On the southern side the intertidal flat is bordered by Hearson Cove Rd and along the northern side there is small network of unsealed roads and two industrial facilities. As such, the intertidal area already exhibits a notable degree of disturbance, vegetation clearing and pre-existing infrastructure as shown in Photos 3 and 4.
